## RIVERBANK ARMY AMMUNITION PLANT BASE REUSE PLAN

Riverbank Local Redevelopment Authority | October 30, 2008

**Approved by the Riverbank Local Redevelopment Authority  
on October 30, 2008.**

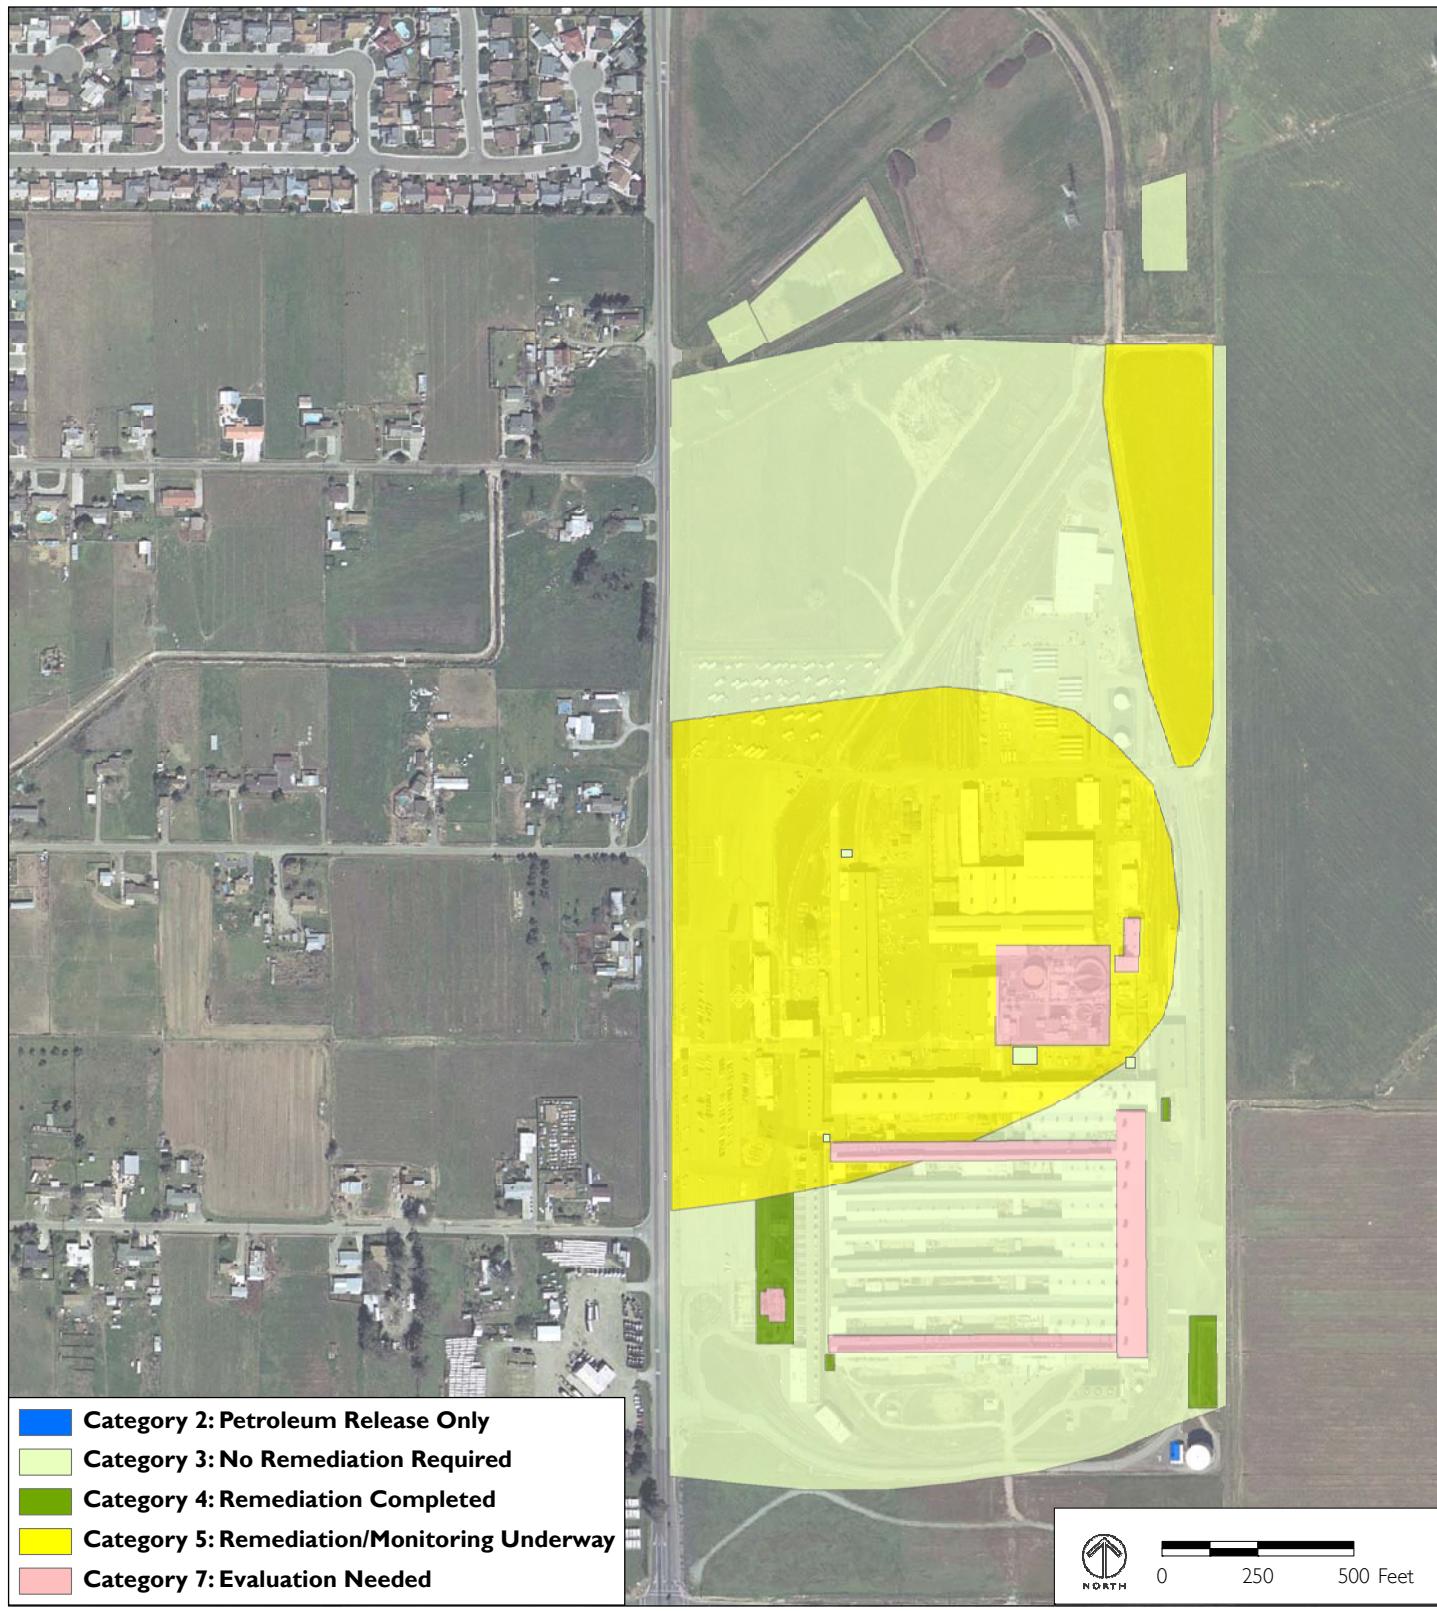
As shown on Figure 1-4, there are several different levels of contamination on the site. The most significant contamination issue is a plume of subsurface groundwater contamination that contains chromium and cyanide; the plume resulted from past spills at RBAAP's Industrial Wastewater Treatment Plant (IWTP). While the defects that caused the spills have been corrected, further treatment is required to remediate the contamination to State and federal standards. There are also other areas with less significant contamination issues, some of which limit where future development can occur. Areas within the RBAAP site were divided into the following seven categories:

- ♦ **Category 1.** No contamination.
- ♦ **Category 2.** Areas where only the release of petroleum has occurred.
- ♦ **Category 3.** Areas where contamination has occurred at a level that requires no further remediation.
- ♦ **Category 4.** Areas where sufficient remediation has already taken place and no further action is necessary.
- ♦ **Category 5.** Areas where contamination has occurred and remediation is underway, but further action or ongoing monitoring is required.
- ♦ **Category 6.** Areas where contamination has occurred, but for which no remediation effort has been implemented (no Category 6 sites were identified at RBAAP).
- ♦ **Category 7.** Areas requiring further assessment.

Map highlights the status of contamination assessments within RBAAP's boundaries.

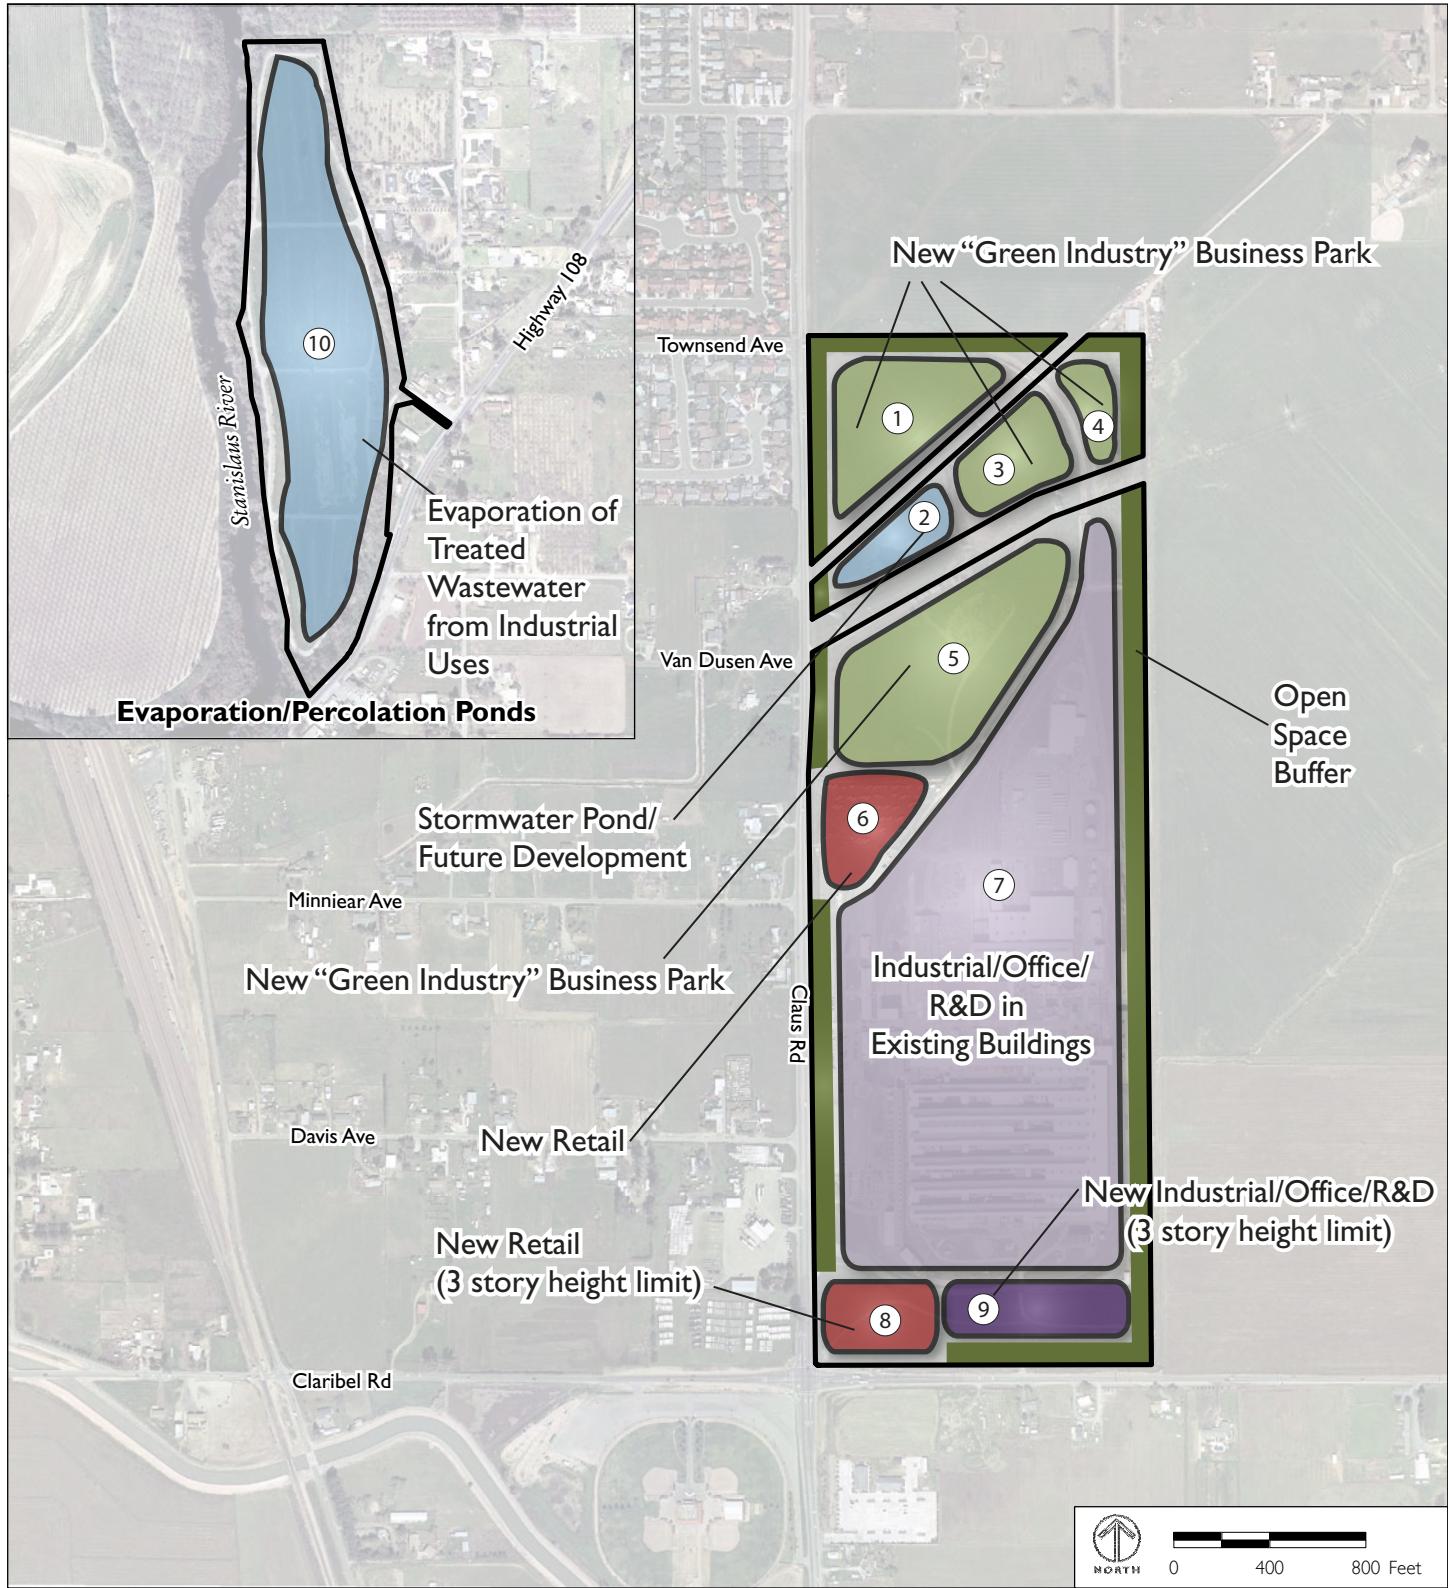
FIGURE 3-2

Figure 3-2 shows the new types of businesses that are proposed for various parts of the RBAAP site. In addition, Figure 3-3 illustrates the potential character of new buildings on the south part of the RBAAP site, standing near Claribel Road and looking west.

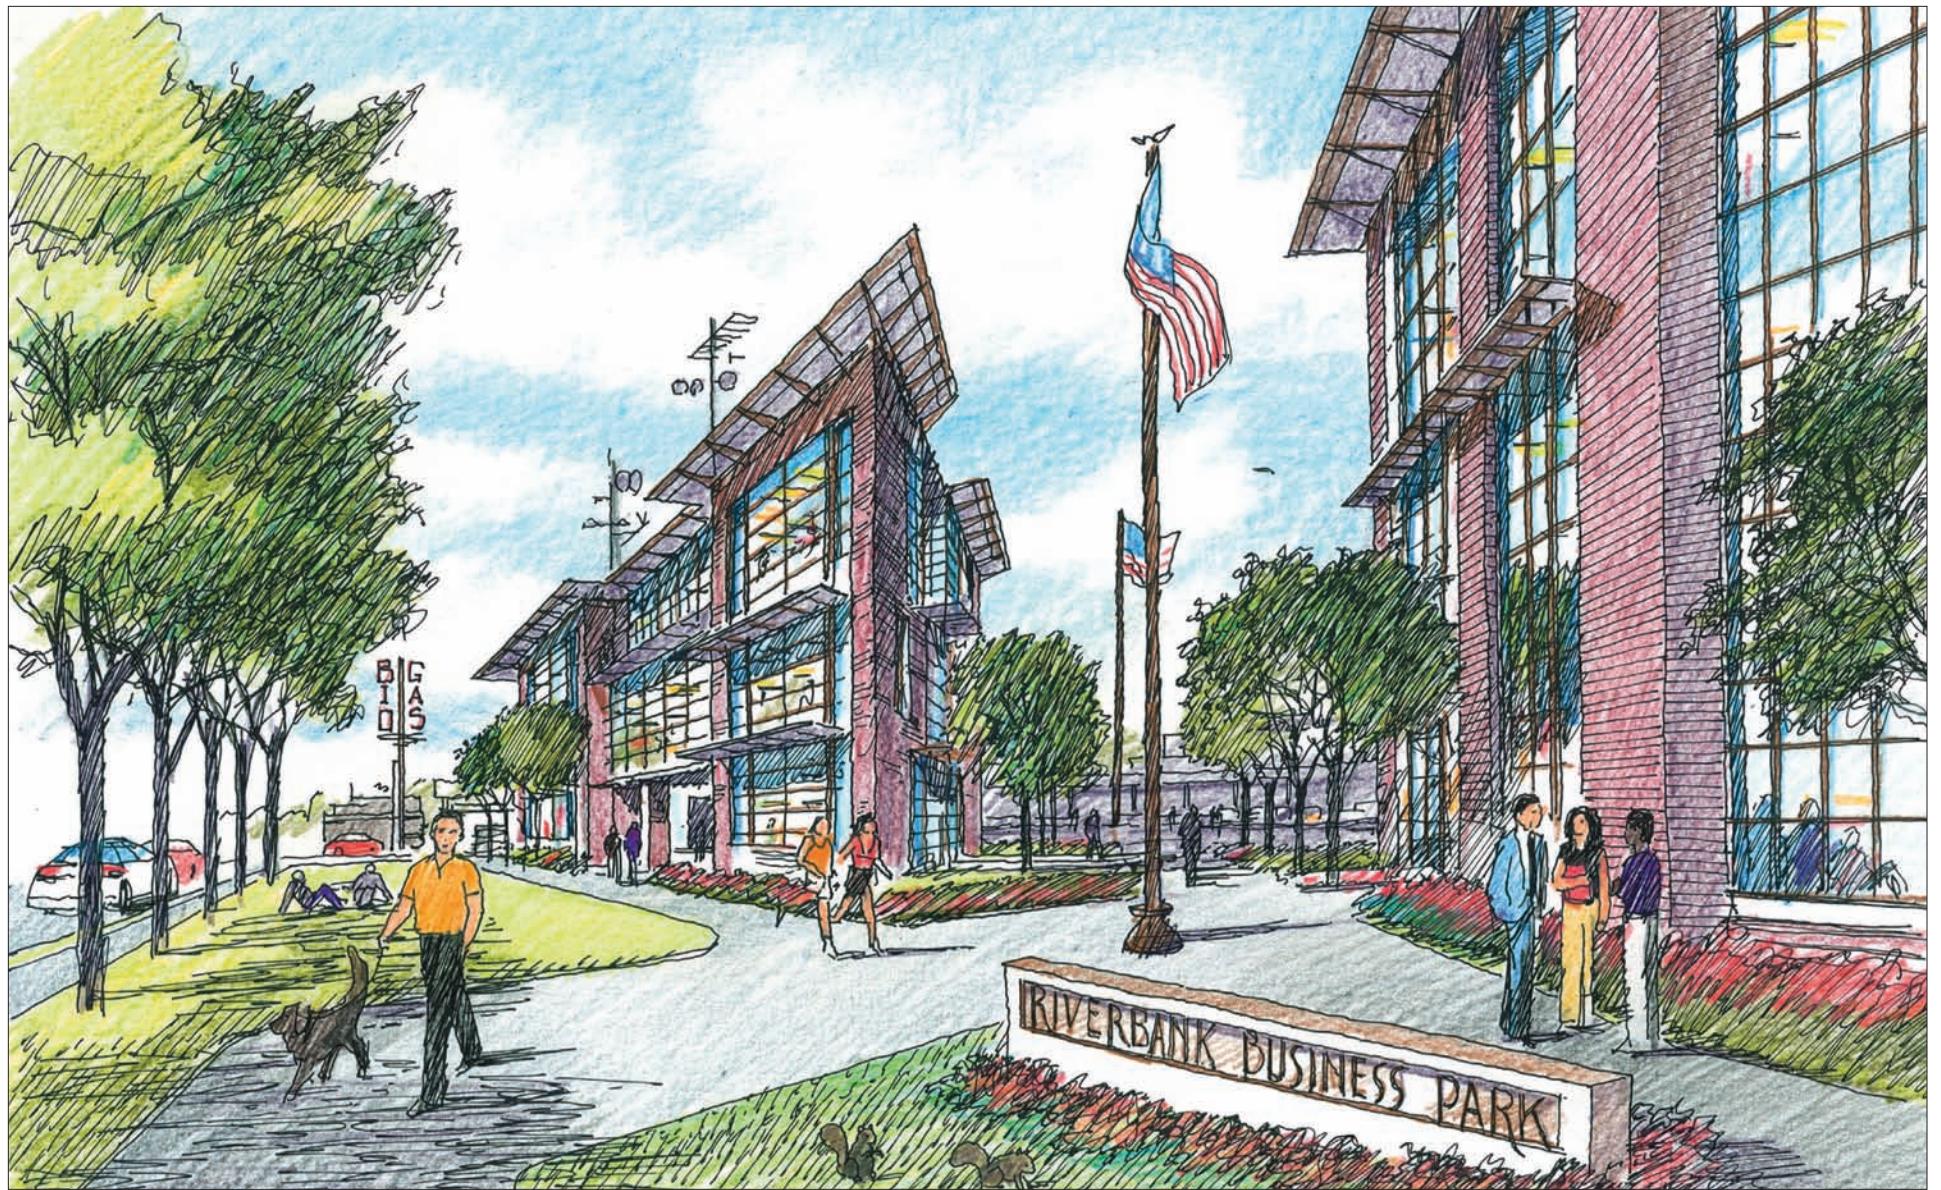
FIGURE 3-3  
RENDERING OF RBAAP CONCEPT: LOOKING WEST ALONG CLARIBEL ROAD

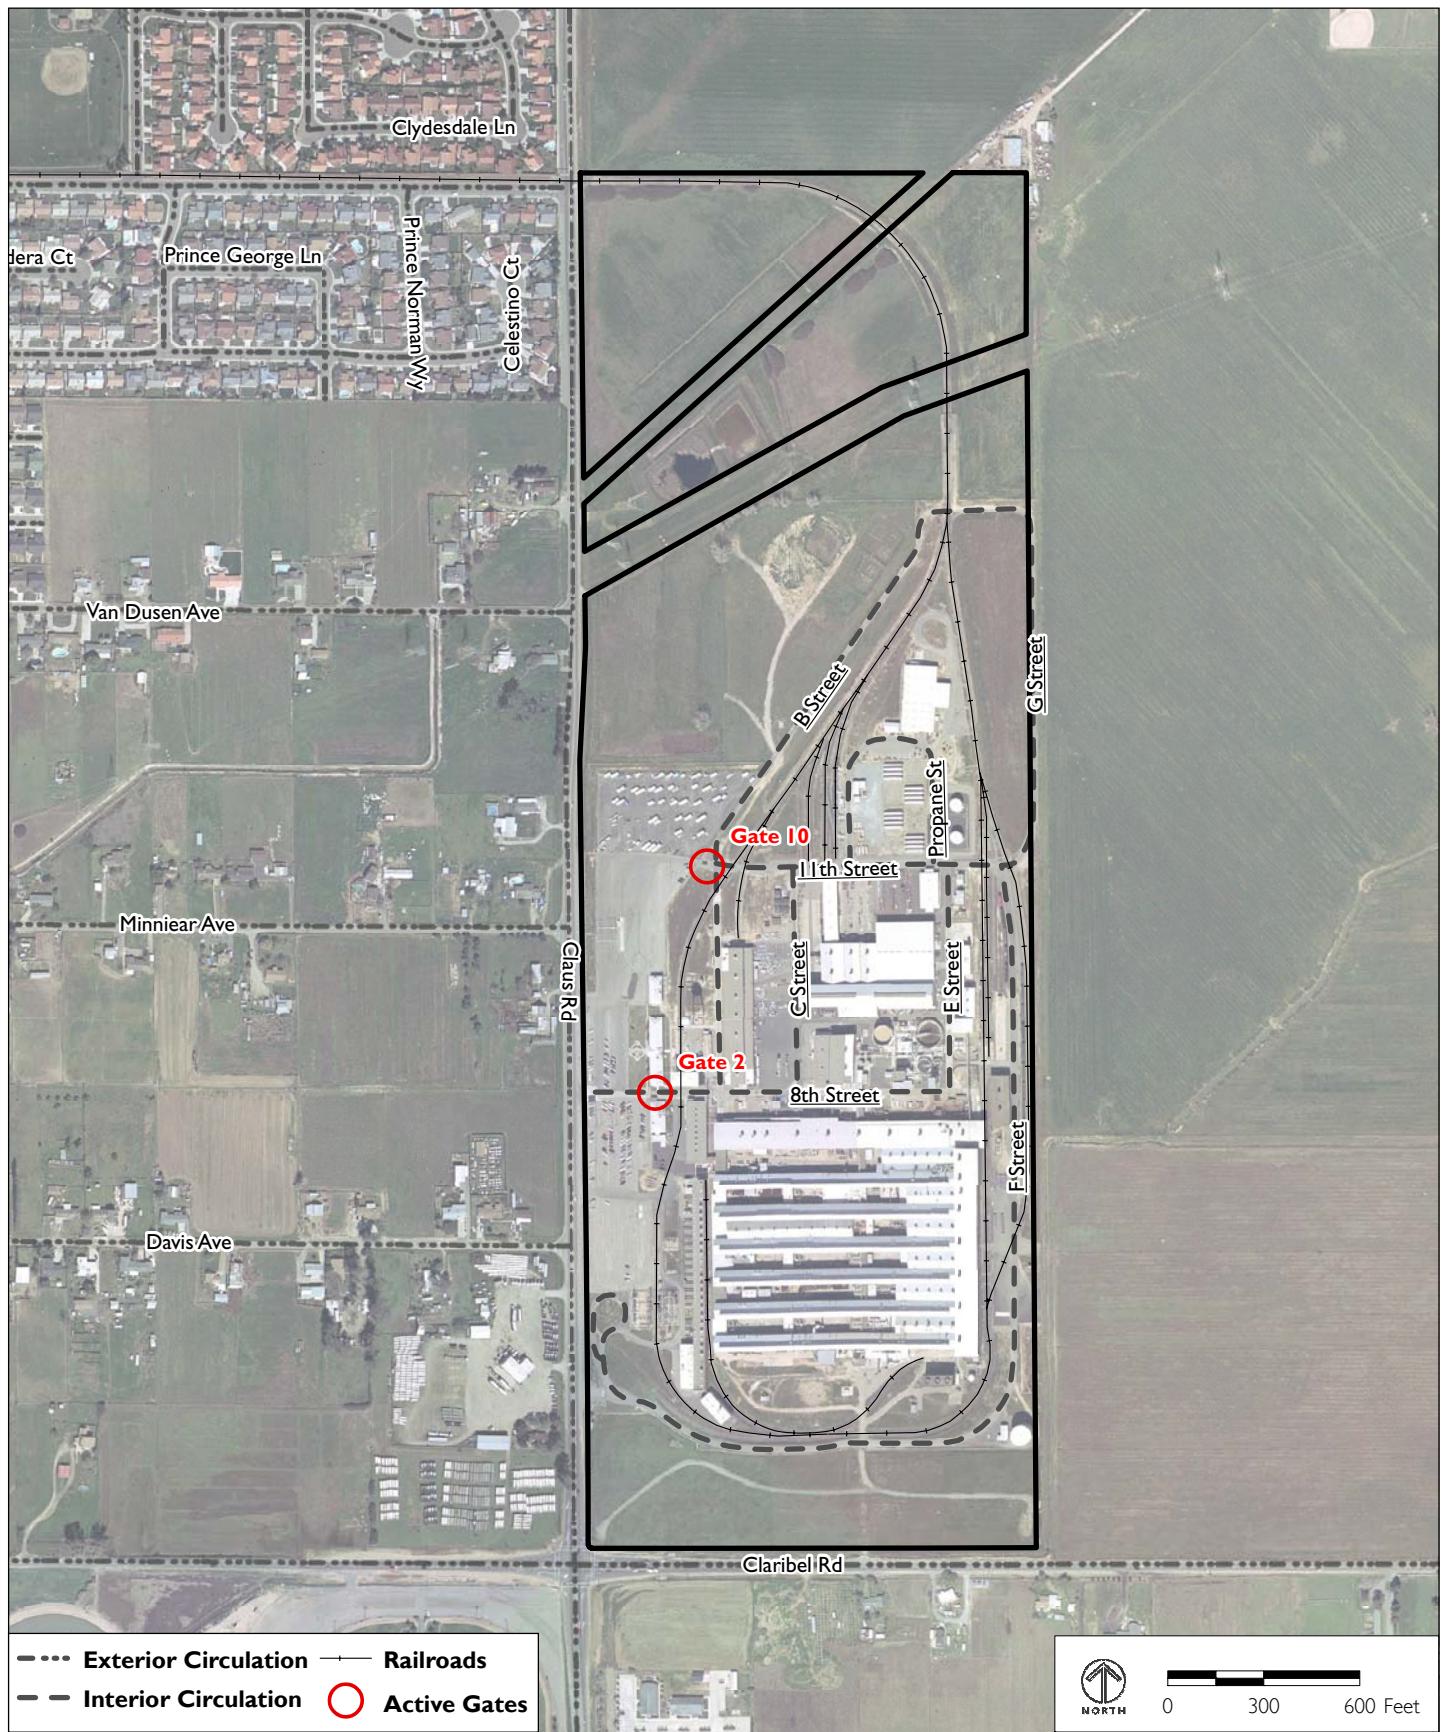
FIGURE 3-4

Movement to and from the site is currently too restricted to comply with these Vision Statements. Specific circulation improvements that will be required include the extension of Van Dusen Avenue through the site, with an at-grade rail crossing at the joint line. Van Dusen Avenue will be connected to the circulation system of the base and is expected to continue east to Eleanor Avenue in the future. To accomplish this, coordination with the San

MAIN SITE CIRCULATION

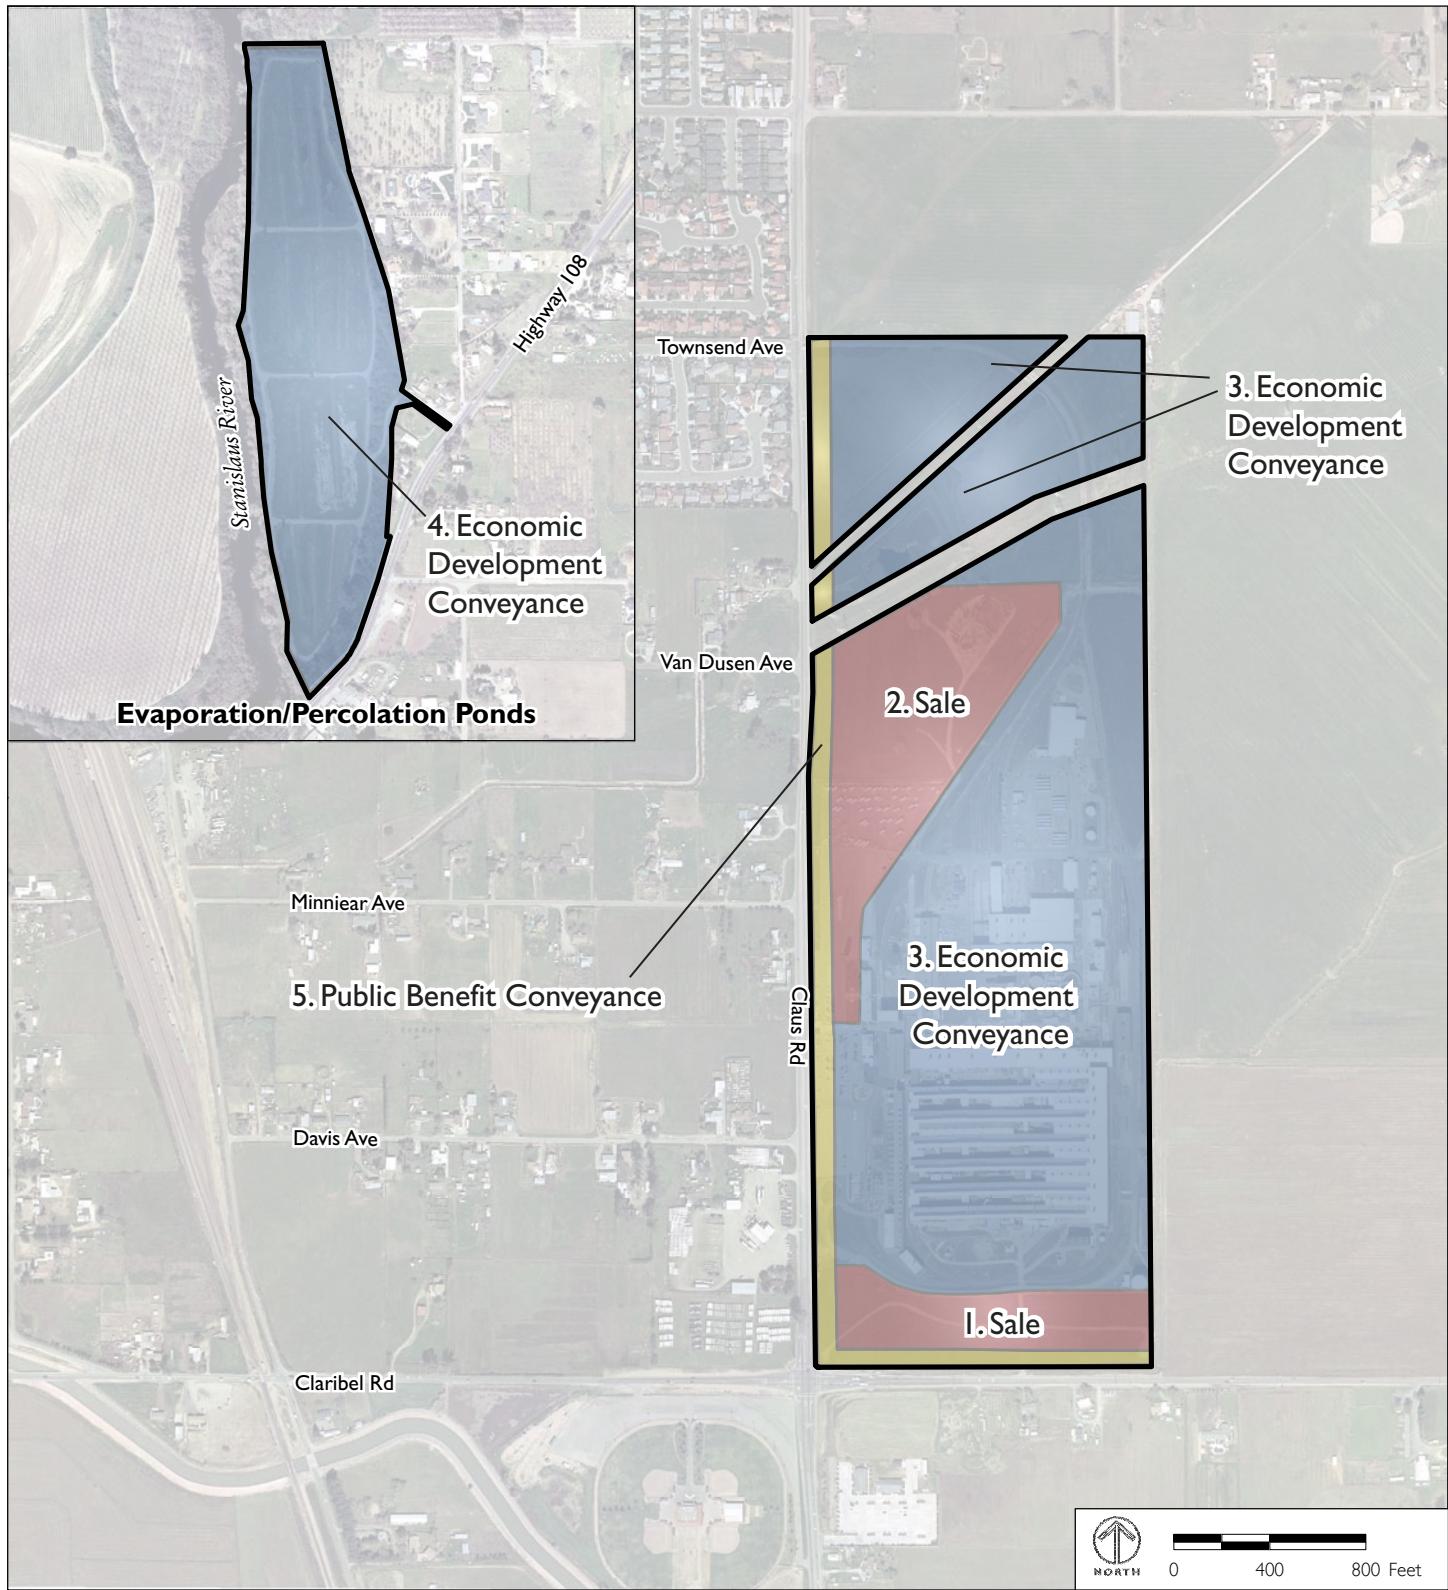
FIGURE 4-1

In accordance with the RBAAP Site Map shown in Figure 4-1, the LRA recommends that the Army dispose of the RBAAP land, facilities, infrastructure and personal property as follows:

## PROPOSED CONVEYANCE METHODS
